**SODOM DAM
(EAST BRANCH RESERVOIR)
PUTNAM COUNTY, NEW YORK
INVENTORY NO. 31**

**PHASE I INSPECTION REPORT
NATIONAL DAM SAFETY PROGRAM**

CROTON RIVER BASIN
SODOM DAM
INVENTORY NO. 31
PHASE I INSPECTION REPORT

Date of Inspection: 27 APRIL 1978

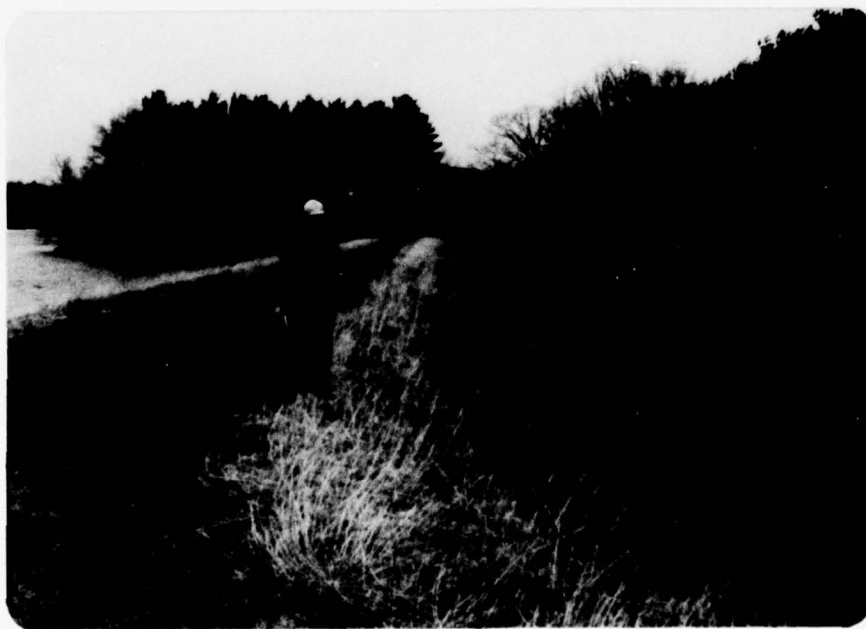
There were no visible signs of sloughing, erosion, cracking or other distress on either the crest or upstream and downstream slopes of the dam. No seepage was visible. There were some minor ruts on the downstream slope; these were apparently caused by the tractor mower used to maintain the grass slope protection. The grass slope protection appeared to be generally well maintained.

EMBANKMENT SECTION, CREST AND DOWNSTREAM SLOPE

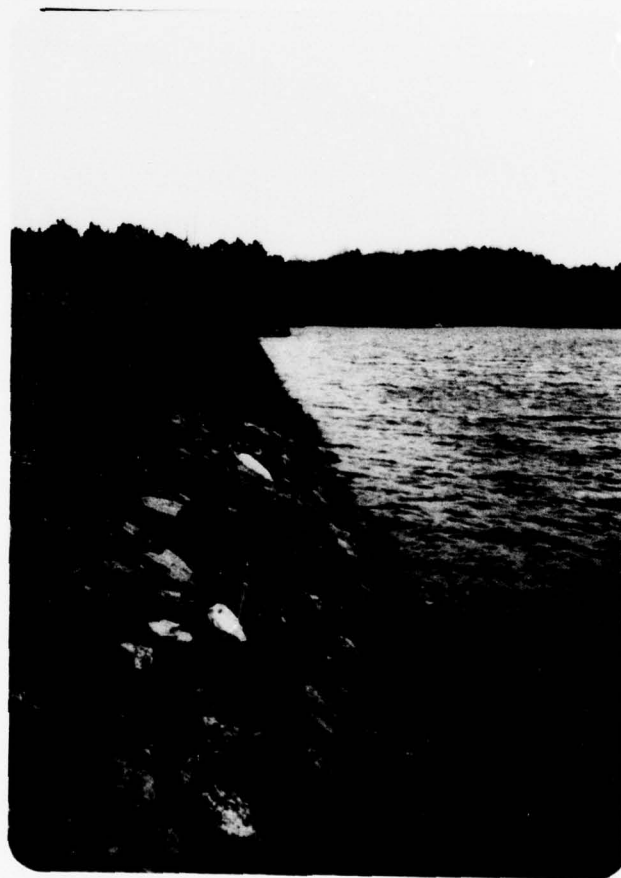
The riprap was hand placed, tight and in good condition.

EMBANKMENT SECTION , UPSTREAM SLOPE
